Docket No. 217 – Development and Management Plan Inspection

Northeast Utilities Service Company Certificate of Environmental Compatibility and Public Need for the construction of a 345-kV electric transmission line and reconstruction of an existing 115-kV electric transmission line between Connecticut Light and Power Company's Plumtree Substation in Bethel, through the towns of Redding, Weston, and Wilton, and to the Norwalk Substation in Norwalk, Connecticut.

Date: August 4, 2005

Location: 345 kV Underground Route

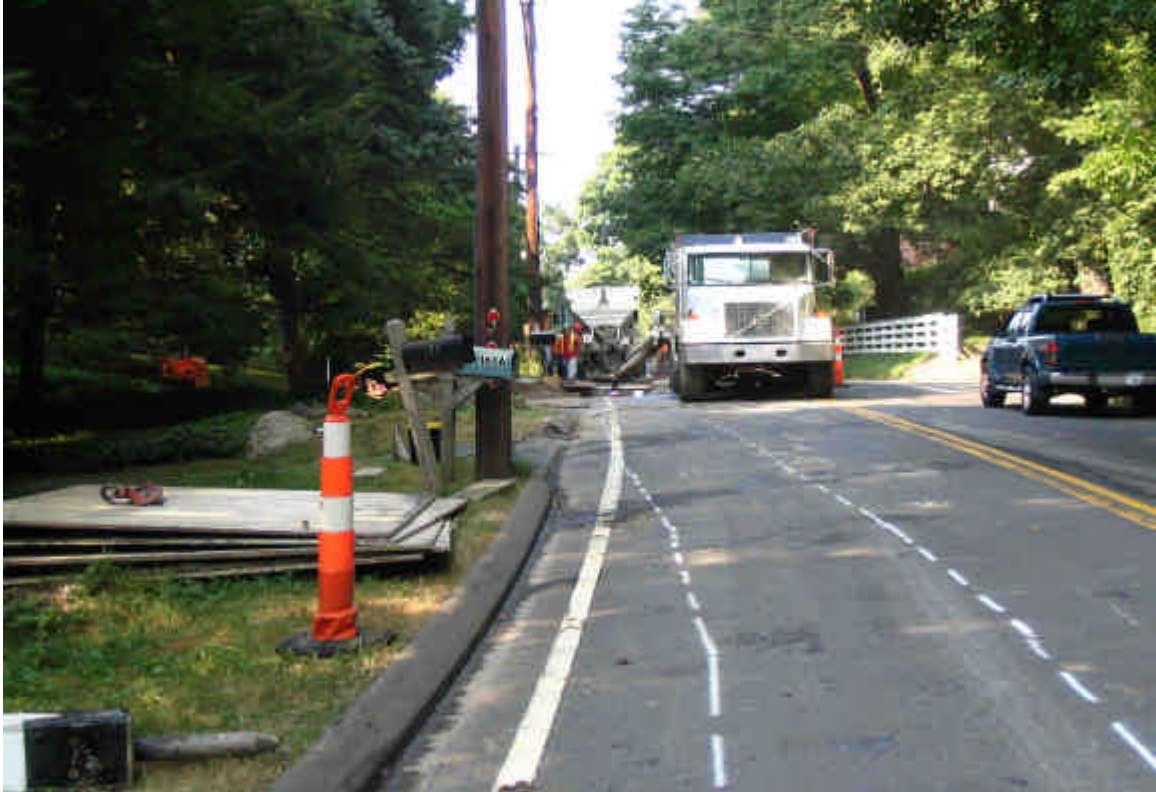
345kV (Rt. 107) View of the day work taking place with active trenching and pipe installation.
(8/4/05)

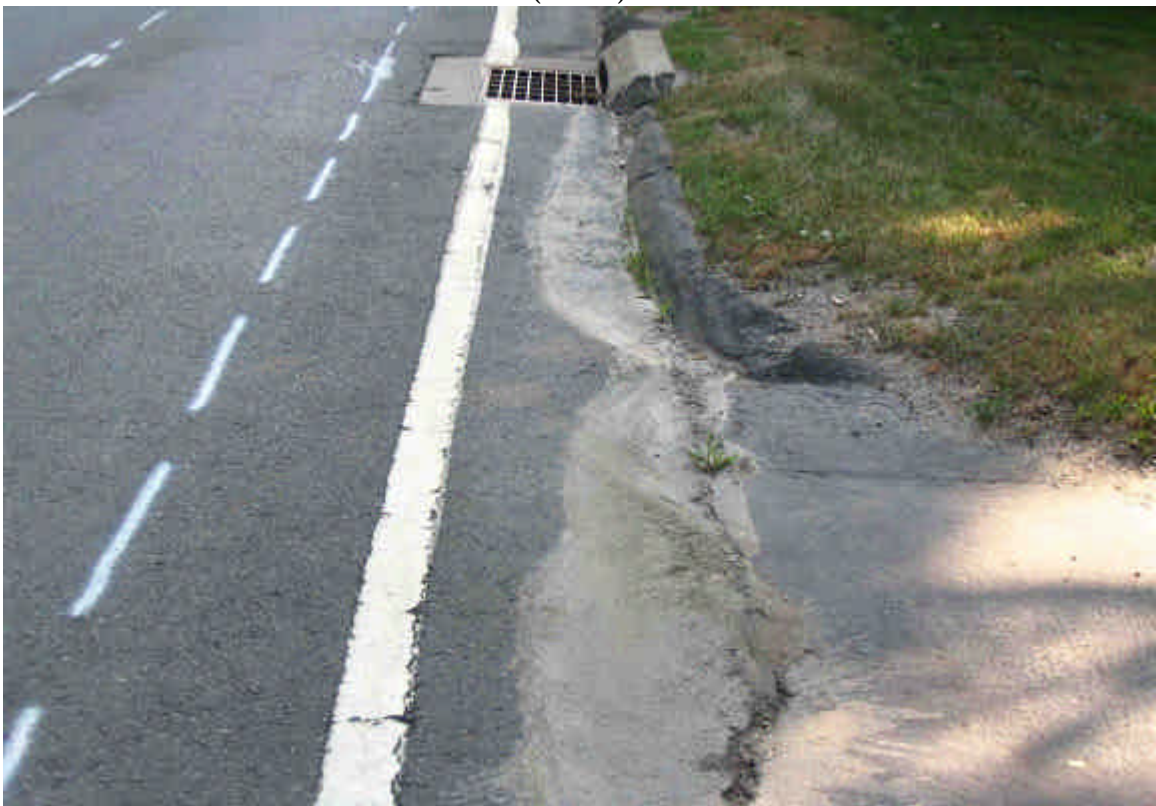
View of a catch basin on Rt. 107 immediately downgradient of the active day work with evidence of sediment flowing to it. The crews here were reminded to protect inlets. (8/4/05)

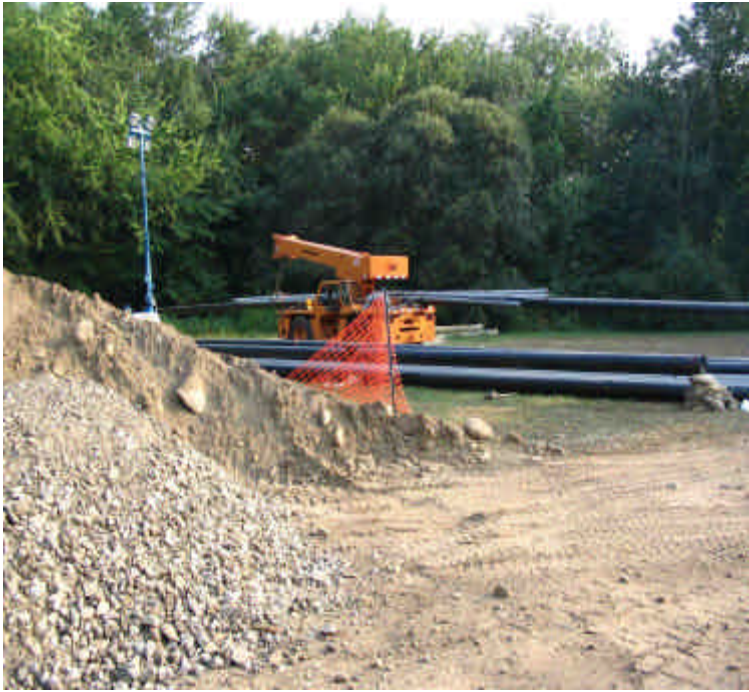
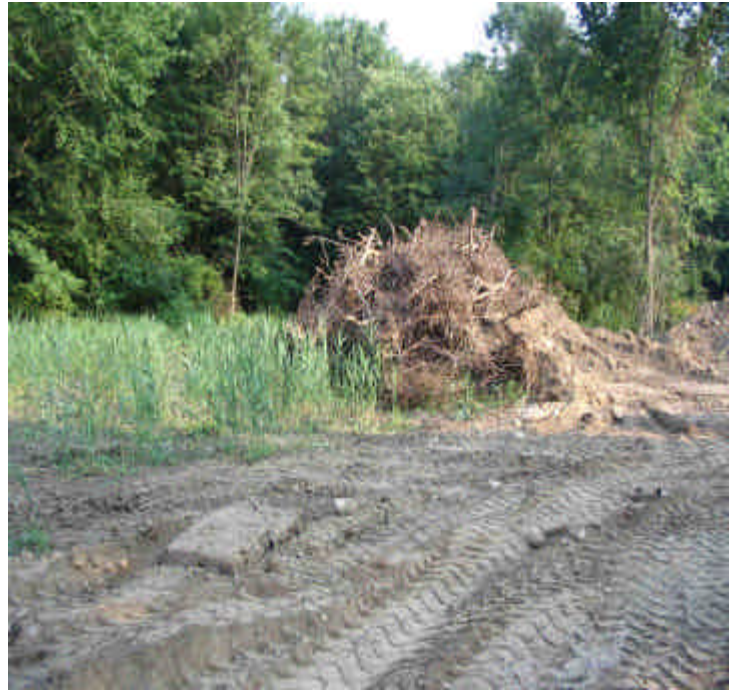
View of the storage area off School Rd. on Rt. 7 which is part of the right of way for the eventual directional drilling. Soil piles were noted here but they will be removed to the storage facility. The brush pile is at the edge of a wetland area and should also be moved. (8/4/05)

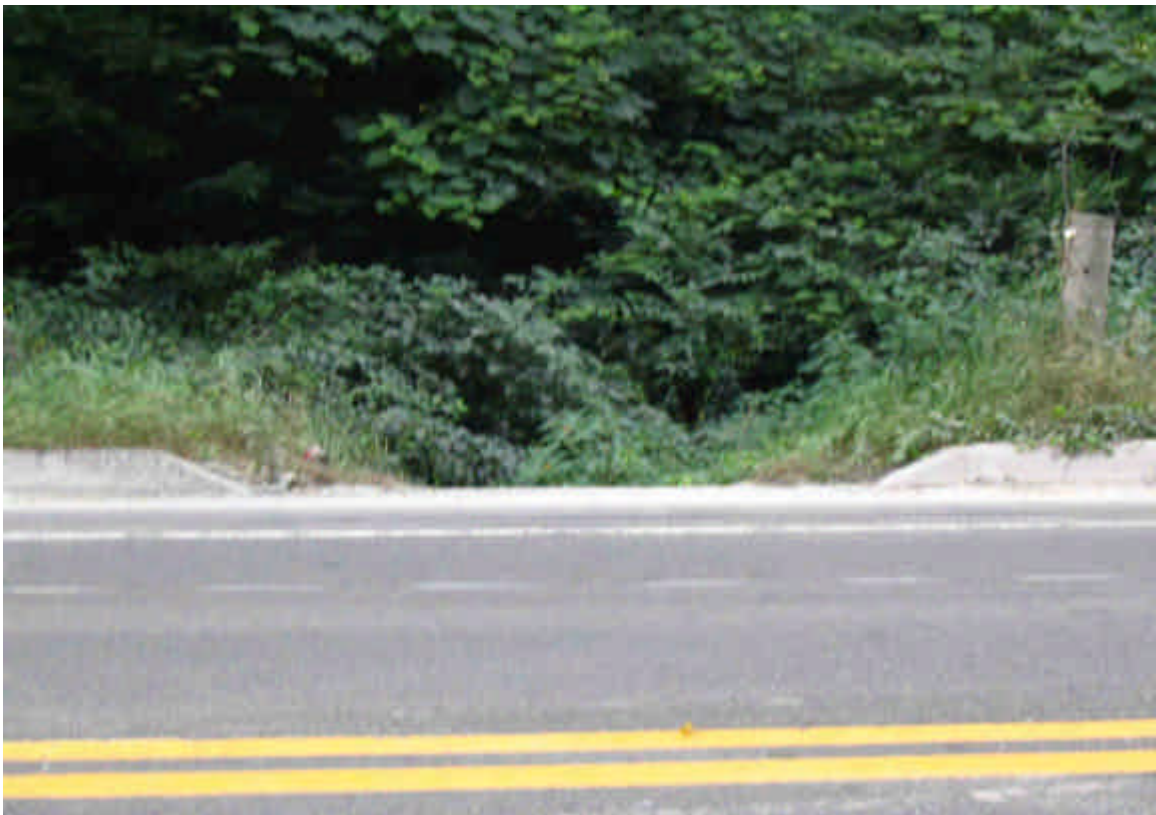
A curb cut across from Seeley Rd should be protected from any slurry muds with silt fence or haybales when active work is in the area. Catch basins in the area look good. (8/4/05)

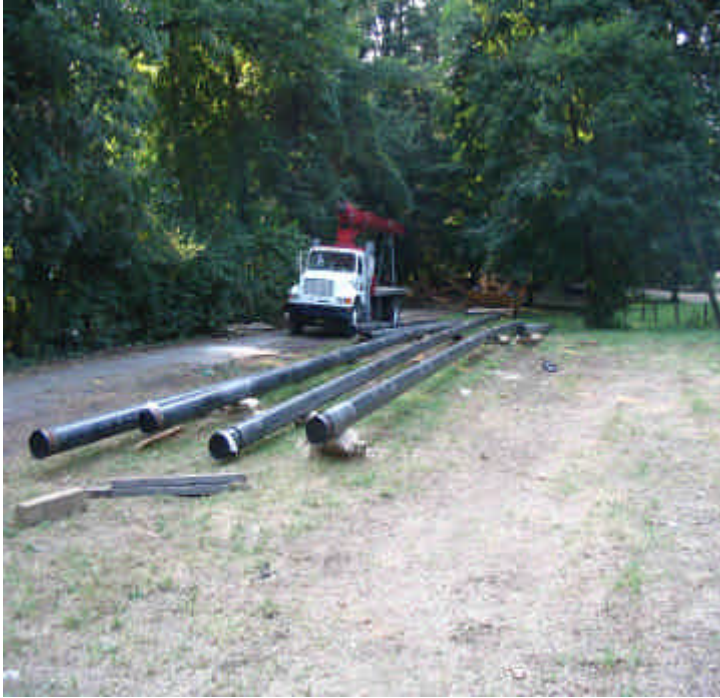
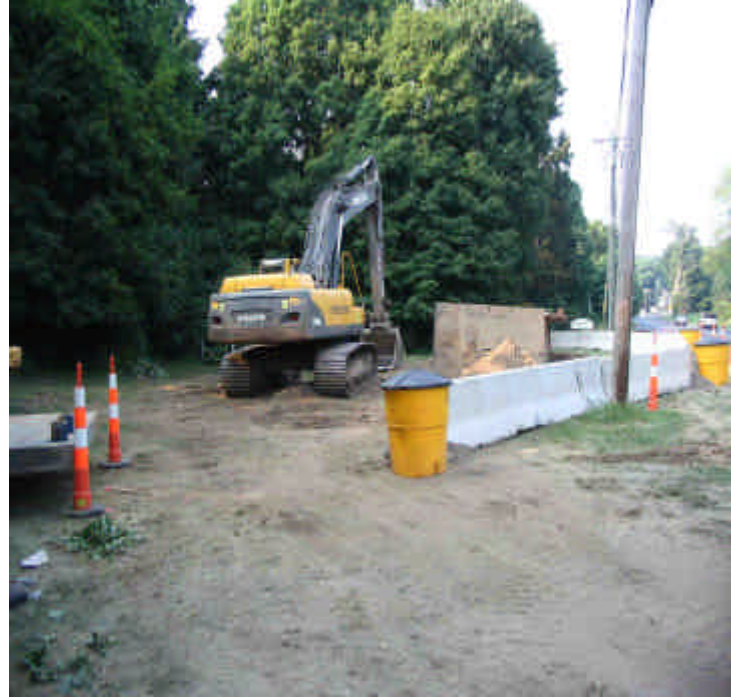
View of several storage and work areas along Rt. 7 off the roadway. (8/4/05)

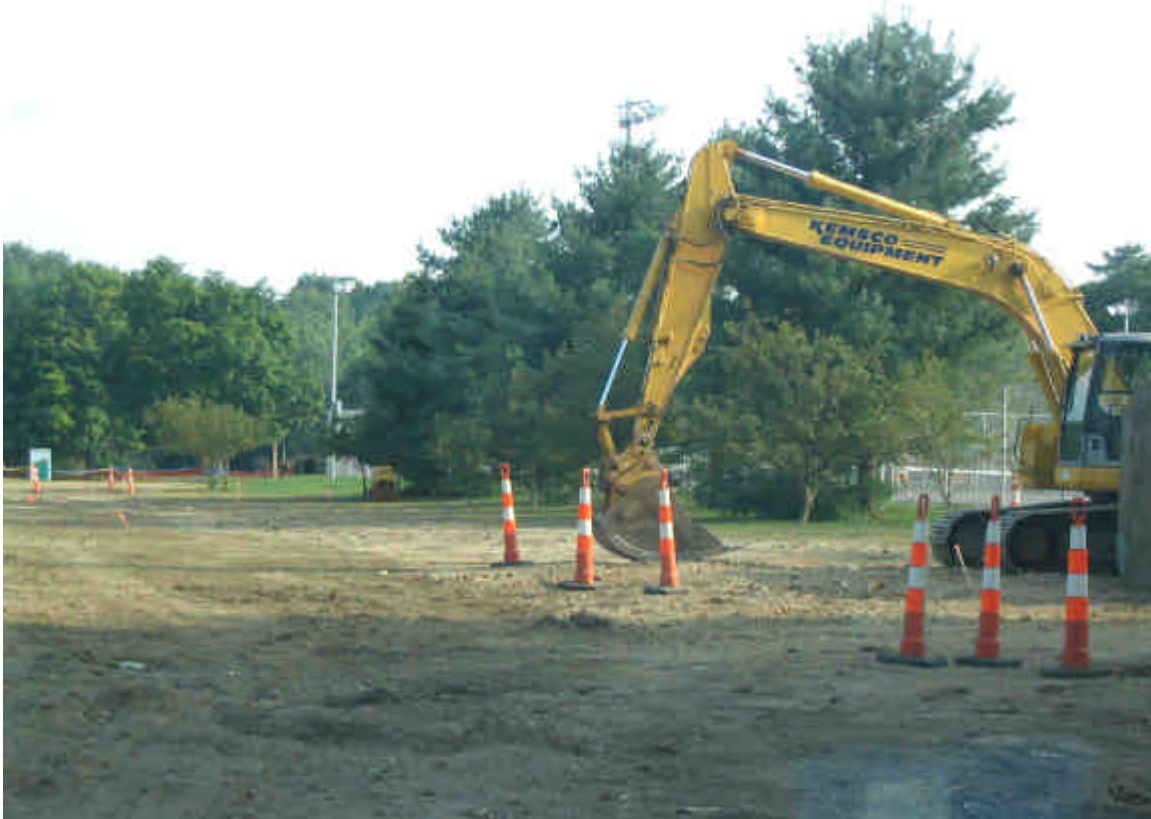
View of work in front of the Wilton High School athletic grounds just off the roadway of Rt. 7. Trenching and a vault installation are proposed in the vicinity. (8/4/05)
